Report No. 86-R-03
AFPEA Project No. 85-P-103

Status Report
of
Free Breathing Static Dehumidification Systems

August 1986

TITLE: Free Breathing Static Dehumidification (FBSDH) System
Field Test Results (Prototype Units)

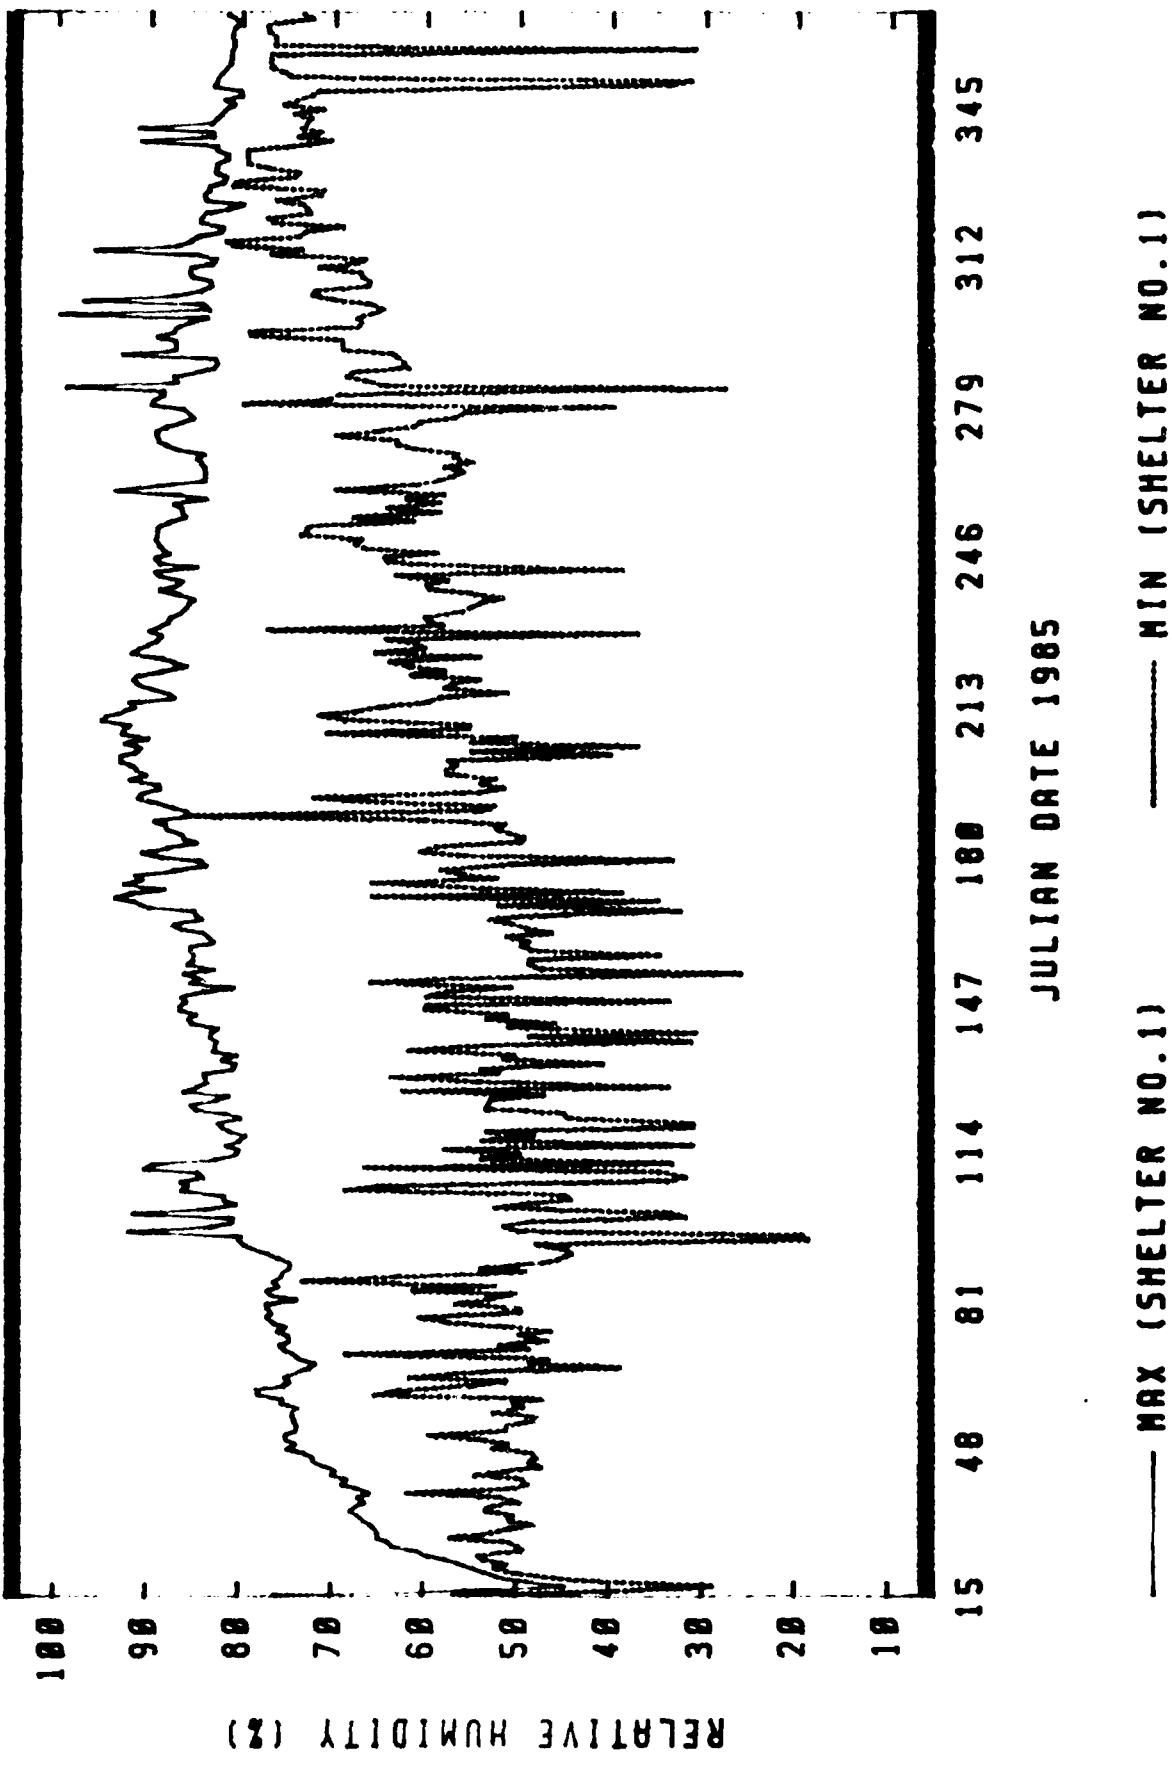
Shelter No. 1: From Table III, the draw-down phase obtained a minimum RH reading of 28.8 percent. From the follow-on data, Figure 14, the interior RH continued to increase as the field service test was continued. No effort was made, however, to restart the field service test since the data was required for evaluation of the FBSDH System. Figure 14 indicates that the interior maximum RH for each day throughout 1985 remained above the 40 percent level. When the draw-down phase was initiated, little temperature cycling occurred (see Figure 15) under high RH environmental conditions (see Figure 16). Therefore, it has been determined that these conditions contributed to the FBSDH system's inability to maintain the internal maximum RH of 40 percent or less. In addition, it has been determined that moisture may have been trapped in the interior walls of the shelter. The sealing operation on the outer surface only allowed the moisture to migrate into the shelter interior and resulted in the high RH readings throughout 1985 (see Figure 14).

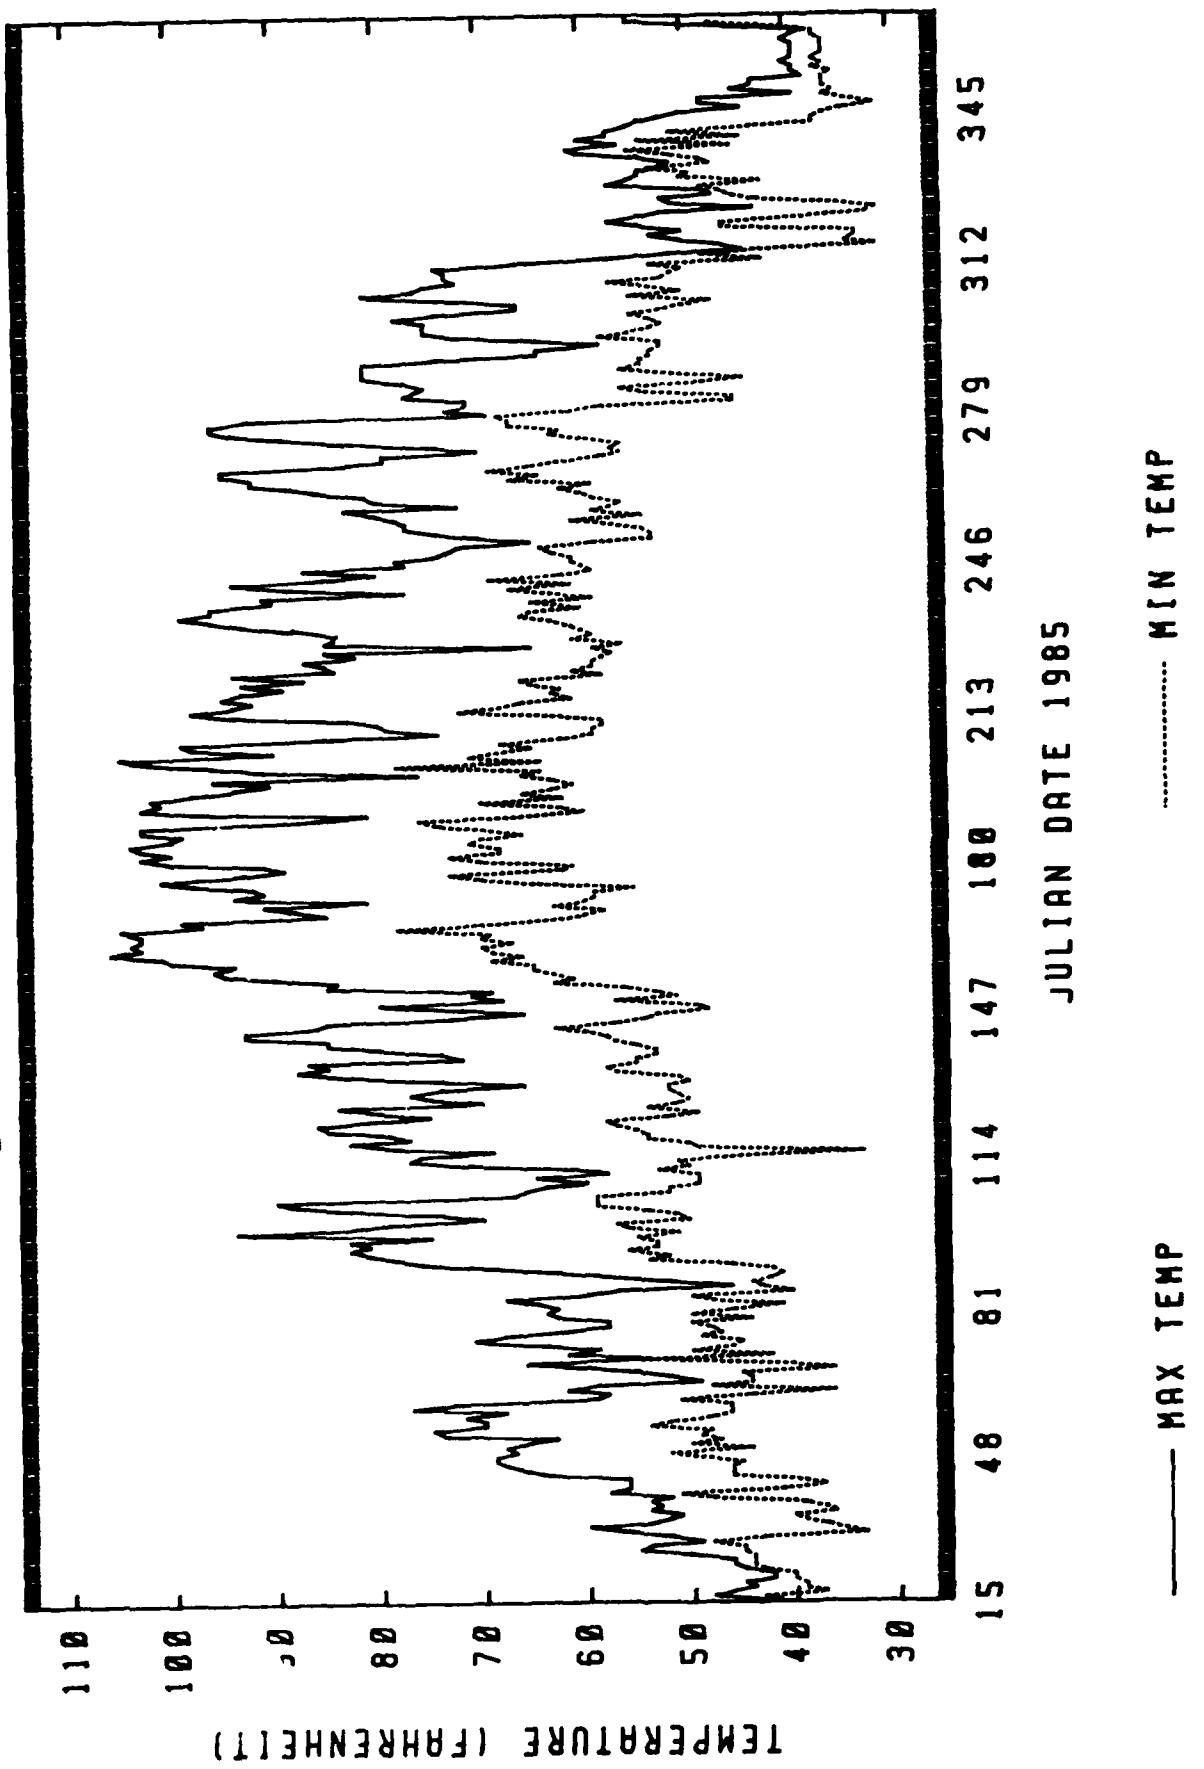
Figure 15

This was evident in the below 40 percent readings throughout August (see Figure 17, Julian date 215 to 244). In the latter part of 1985, from September to December, the temperature difference for each day decreased (see Figure 15), indicating less breathing. This caused the internal RH to increase (see Figure 16). Visual examination of the shelter exterior did not reveal any deterioration to the sealed areas; therefore it had been determined that the lack of temperature cycling caused the higher interior RH recordings. The field service test is being continued for additional data.

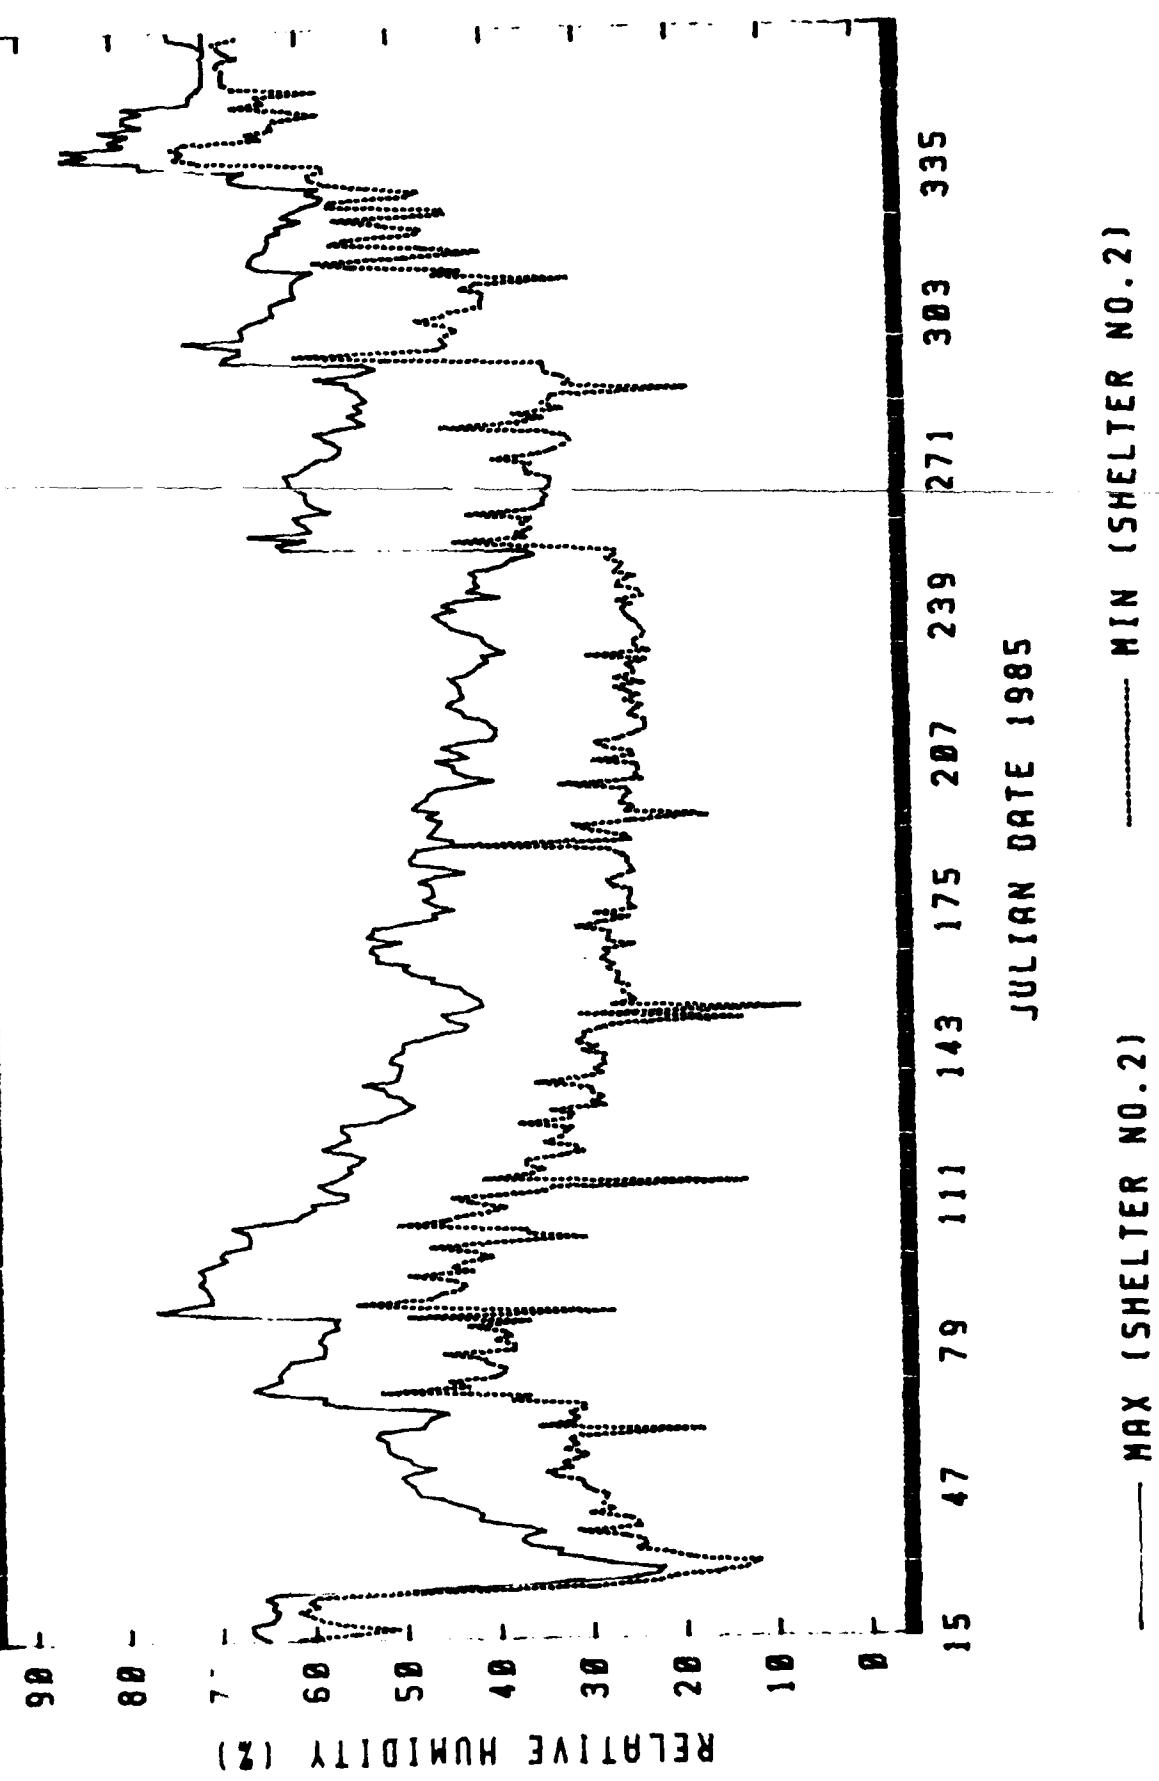
Shelter No. 2: The draw-down phase, Table III, obtained a minimum RH reading of 11.9 percent and was considered satisfactory to start the service phase. The data from Figure 17 displays the interior maximum RH for 1985 below the 40 percent level only after the draw-down phase and throughout the month of August. This indicates that the draw-down phase did reduce the interior RH and that moisture migrated from the interior of the walls and was absorbed by the FBSDH system. This resulted in the higher interior RH readings for the first 3 months of 1985 (see Figure 17). However, from April to August greater temperature cycling occurred, promoting the FBSDH system to reactivate itself and dissipate the absorbed moisture into the external environment.

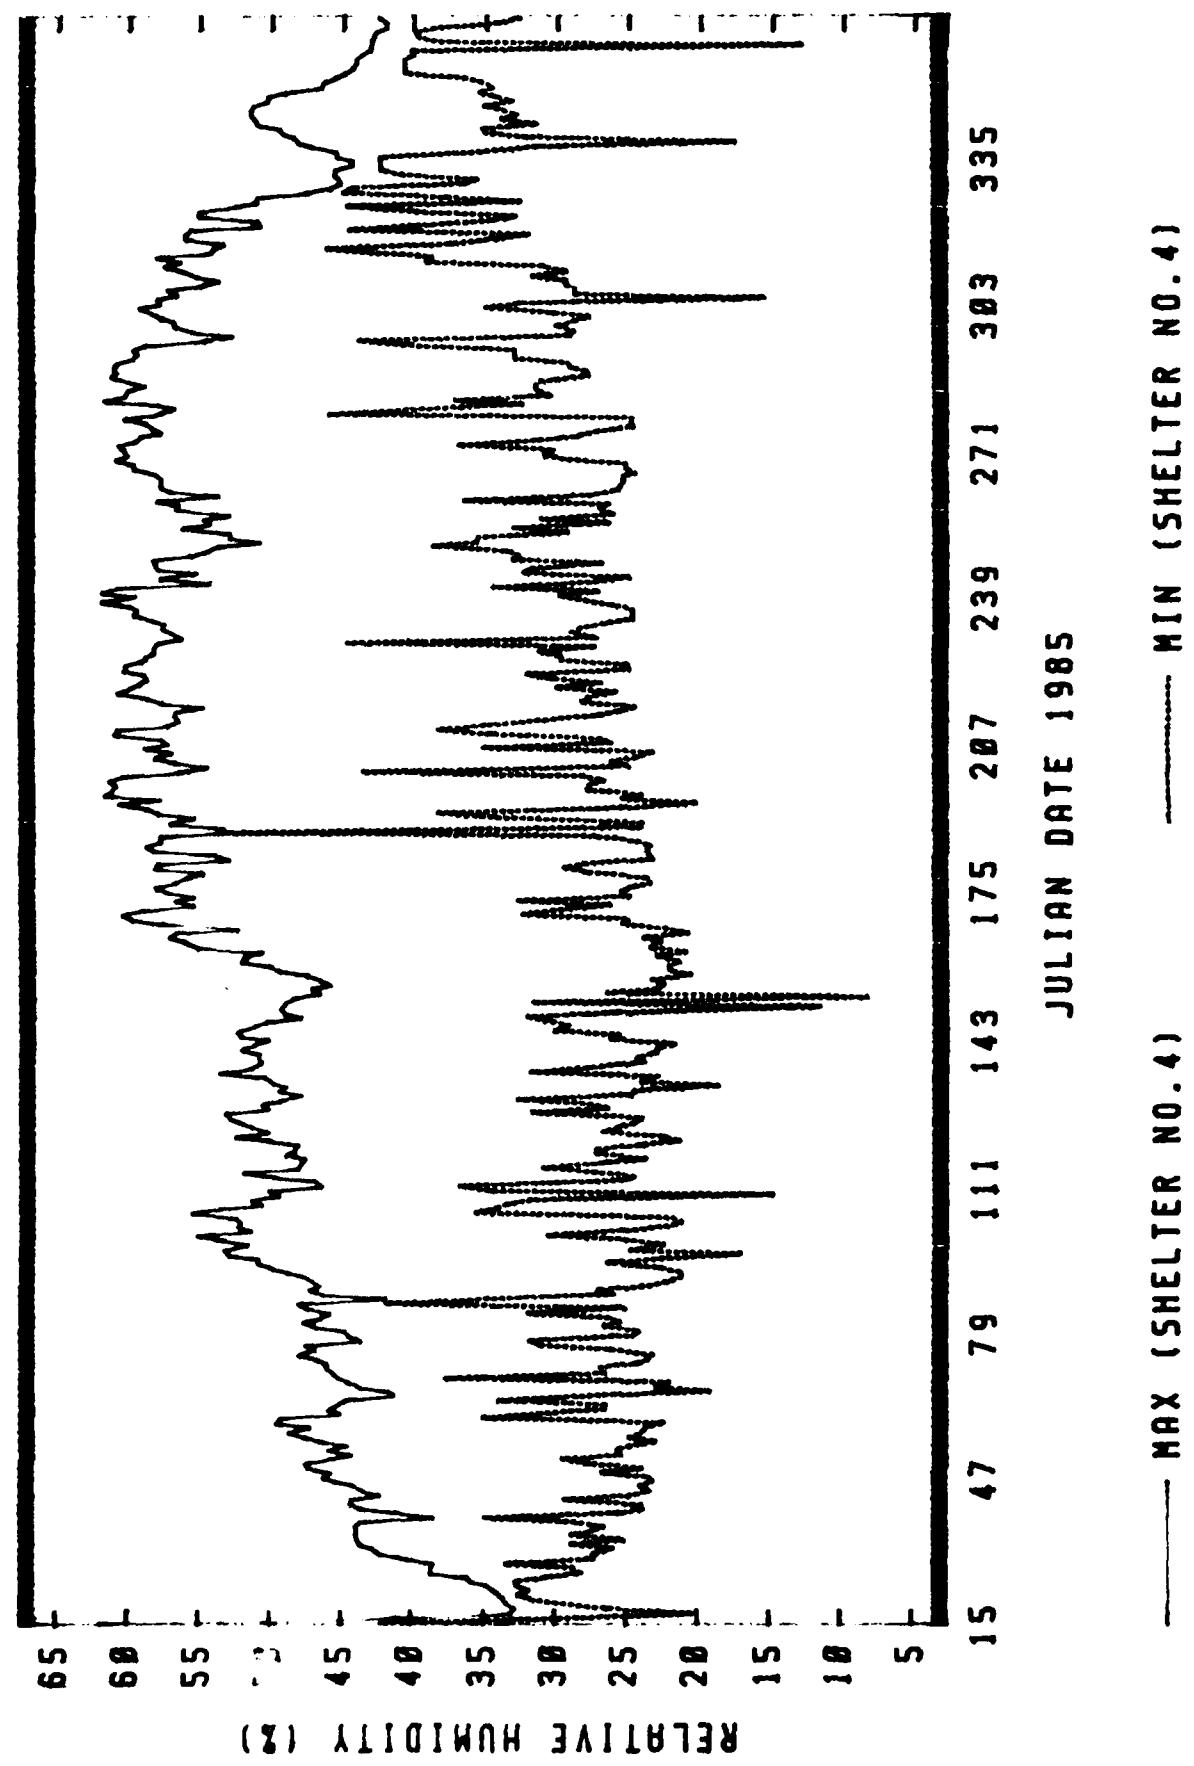
Shelter No. 4: The draw-down phase, Table III, obtained a minimum RH of 20.7 percent and was considered satisfactory to initiate the service phase. Figure 19 displays the draw-down phase, 15 to 17 Jan 1985, reduced the internal maximum RH to 33 percent. The internal maximum RH gradually increased to the 55 to 60 percent level until mid-June and remained at that level until the end of November. It had been determined that moisture migrated from the interior of the shelter walls and was absorbed by the FBSDH system. This resulted in the 55 to 60 percent RH level from June to November. At the beginning of December, the internal maximum RH decreased gradually over a two week period to approximately 45 percent, then increased to approximately 52 percent (see Figure 19). This increase in internal RH corresponds to an increase in the environmental RH and rainy conditions (see Figure 16). Finally, the year closed with a internal maximum RH of 42 percent and it appeared the FBSDH system began to reactivate itself. Testing is being continued for additional data.
